# **OPERATING EXPERIENCE WEEKLY SUMMARY**

**Office of Nuclear and Facility Safety**

**July 2 - July 8, 1999**

**Summary 99-27**

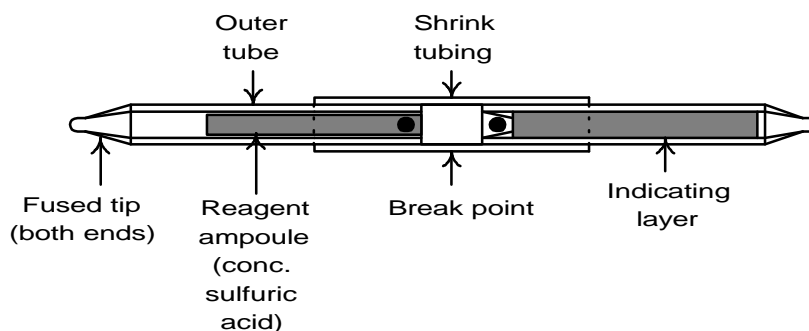
**Figure 1-1. Dräger Oil 10/a-P Indicator Tube**

On June 30, 1999, at the Argonne National Laboratory—West, an employee performing an oil vapor test on a breathing air system was burned by concentrated sulfuric acid expelled from a Dräger tube. The employee received burns to the right side of the neck, the right forearm, and the little finger of the left hand. He and a co-worker ran to an adjacent building and began a 15-min water wash of the burned areas. The co-worker drove the employee to the site dispensary, where he showered for another 15 min. Site safety and health personnel transported the employee to a regional medical center, where he was treated and released with the recommendation to follow up with a physician. Exposure to the acid caused the skin to redden and blister. (ORPS Report CH-AA-ANLW-ANLW-1999-0005)

Laboratory personnel double-bagged the broken tube and took it to an on-site analytical laboratory for examination. The distance traveled by the acid indicates that it was expelled under pressure. The moisture sample taken just before the oil sample contained more than 450

mg/m<sup>3</sup> of water vapor, and laboratory personnel believe that the acid may have reacted exothermically with moisture introduced with the sample, providing the energy to expel the acid.

- Break the tubes in a direction away from themselves and others.
- Consider breaking the tubes inside a short length of thin-walled polyethylene tubing.
- Perform water vapor samples and correct moisture problems before performing oil vapor tests.
- Consider wearing eye protection and gloves when handling the tubes.
